**BUILDINGS 107, 289, AND 291 DEMOLITION
HABS/HAER ARCHITECTURAL ASSESSMENT
HOLLOMAN AIR FORCE BASE
OTERO COUNTY, NEW MEXICO**

REPORT OF INVESTIGATIONS
No. 120EP

January 1998

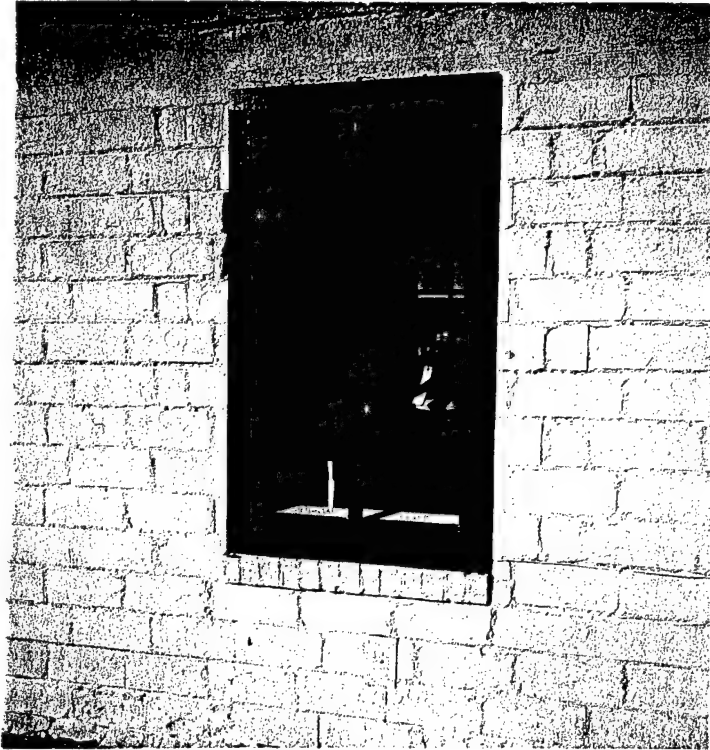
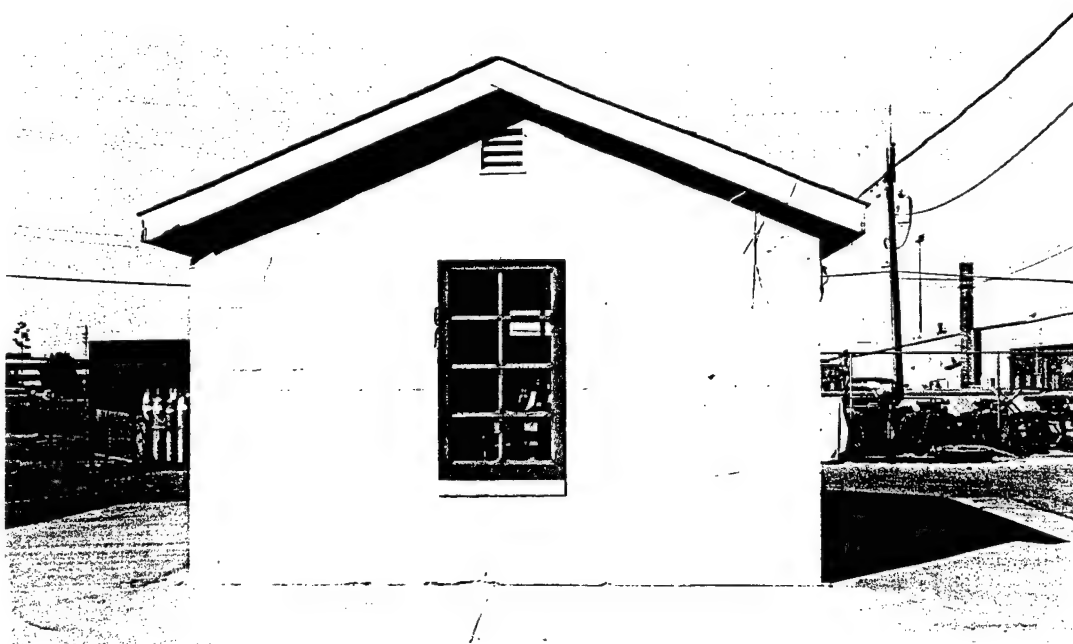
Figure 14. Building 289 window detail, northeast elevation.

Two windows are centrally located, one each at the southwest and northeast elevations. Each window has been replaced with Plexiglass, due to storm damage to the original wooden windows in 1995 (Tagg, 1996 personal communication). A painted wood muntin grid is attached to 1 x 4-inch wood trim. A row of bricks on edge forms the sill. Framed wood louvers are centrally located above each of the two windows, just below the gable (Figures 14 and 15). The southeast elevation has no openings.

Figure 15. Building 289 window with framed wood louver, northeast elevation.

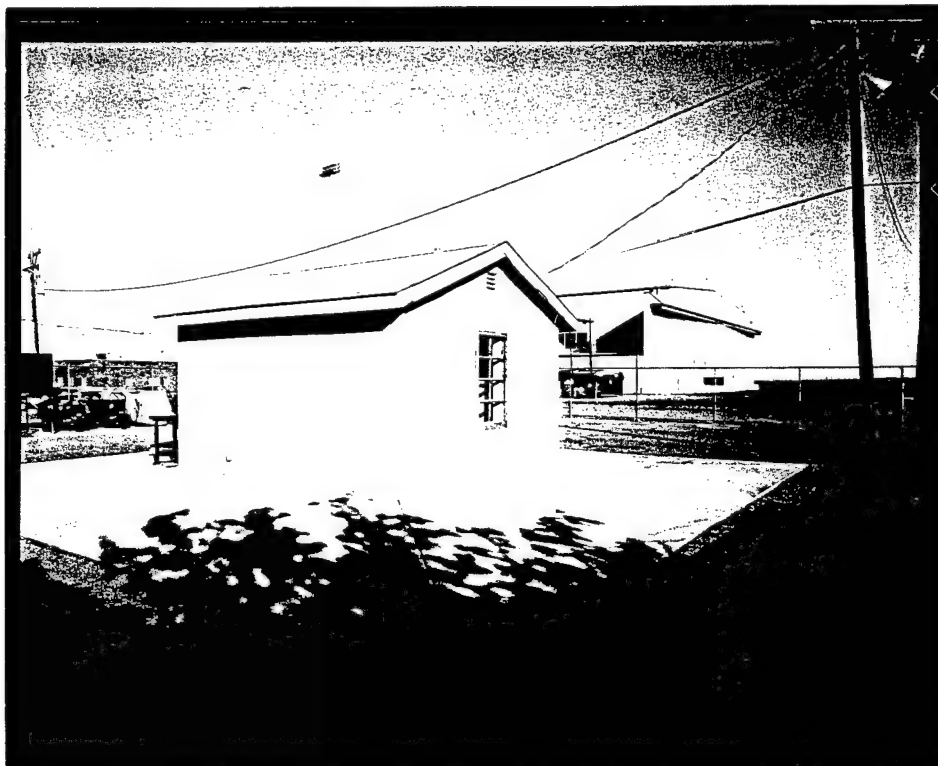
Figure 16. Building 289, east elevation, Building 291 in background.

Real Property Accountable Record/289 indicates that Building 289 was not necessarily associated with any particular hangar or building, but provided storage for the base, in general. However, Building 289 may have been historically associated with Building 291, an aircraft hangar just 200 ft to the northwest (Figure 16).

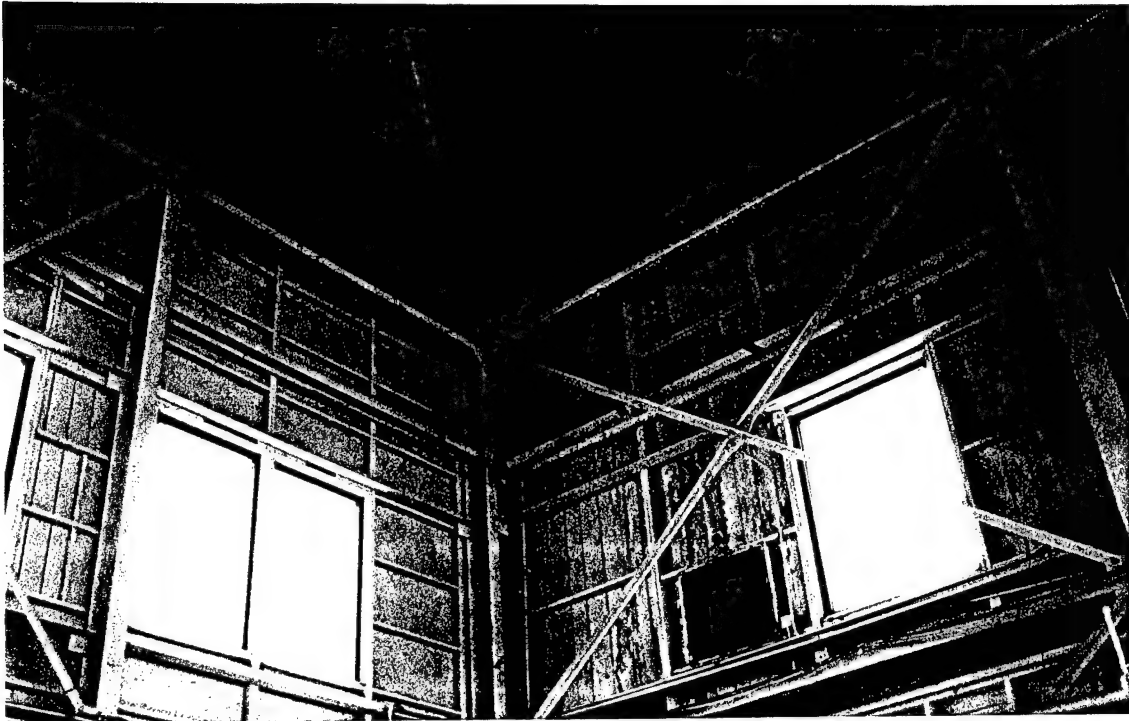
Figure 20. Building 291 interior, braced 'H' columns and spandrels.

Built on a 6-inch concrete slab foundation with concrete piers, the clear floor width is approximately 100 ft. The steel trusses of the roof structure are supported by 'H' columns that are diagonally braced and support intermediate spandrels (Figure 20). The clear height to the bottom chord of the truss system is approximately 29 ft. The quadrangle shape of the trusses forms the slightly pitched, gable roof. The roof is felt roofing material on wood deck, supported by steel purlins. The exterior walls are covered with an insulation and siding system.
